# Avoiding Roofing Errors: Layout Problems, Incorrect Kickout Flashing, and Leaking Metal Flashing

When it comes to keeping water out of a building, fine details matter.

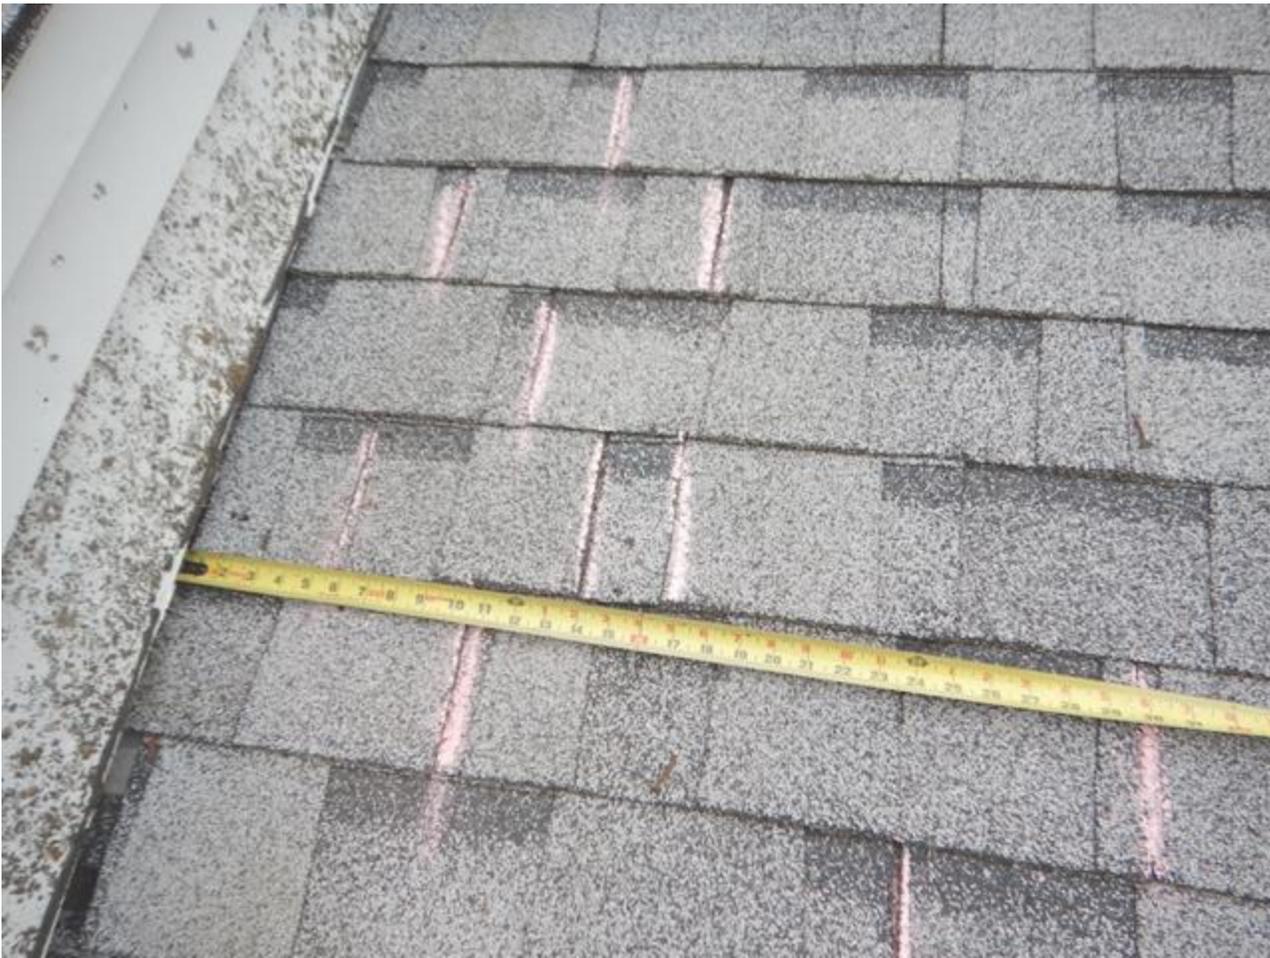
**Parlee Shingle layout.** The chalk lines above show the joints between the shingles. To prevent water leaking into the gap, shingle makers typically require a minimum 4-inch overlap.

- **Layout problems.** Shingles frequently have an inadequate offset between courses. Most shingle manufacturers require a minimum 4-inch offset to allow the overlap of shingles to deflect water.

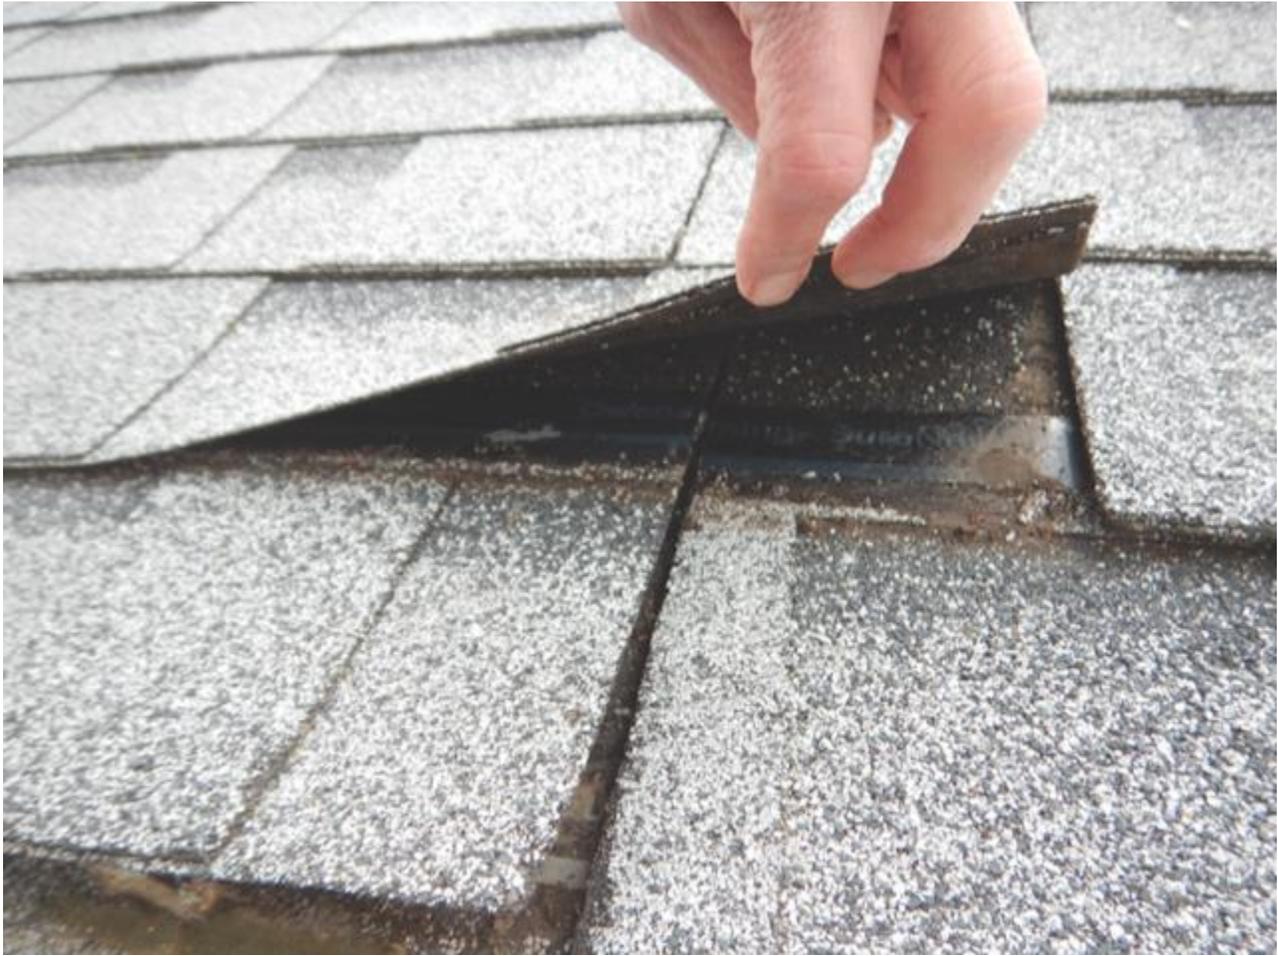
**Mark Parlee Shingle nailing.** Shingles must be nailed at the ends, which did not happen in the roof pictured.

- **Nailing problems.** Shingles are nailed haphazardly. In many cases, nails were left out entirely, especially at shingle ends, or nails were overdriven or crooked.
- **Failure to include any step flashing** at all at roof-wall intersections or poor integration of step flashings with the roof shingles.
- **Missing drip edge.** Omission of drip edge along the gable ends of roofs is most common, but surprisingly, sometimes drip edge is entirely missing from all roof edges. Without a metal drip edge, water will cling by capillary force and leak under the shingles. Unsupported edges are also prone to deterioration from snow, wind, ladders, and foot traffic. (Rare as the latter might be, it's still an issue.)

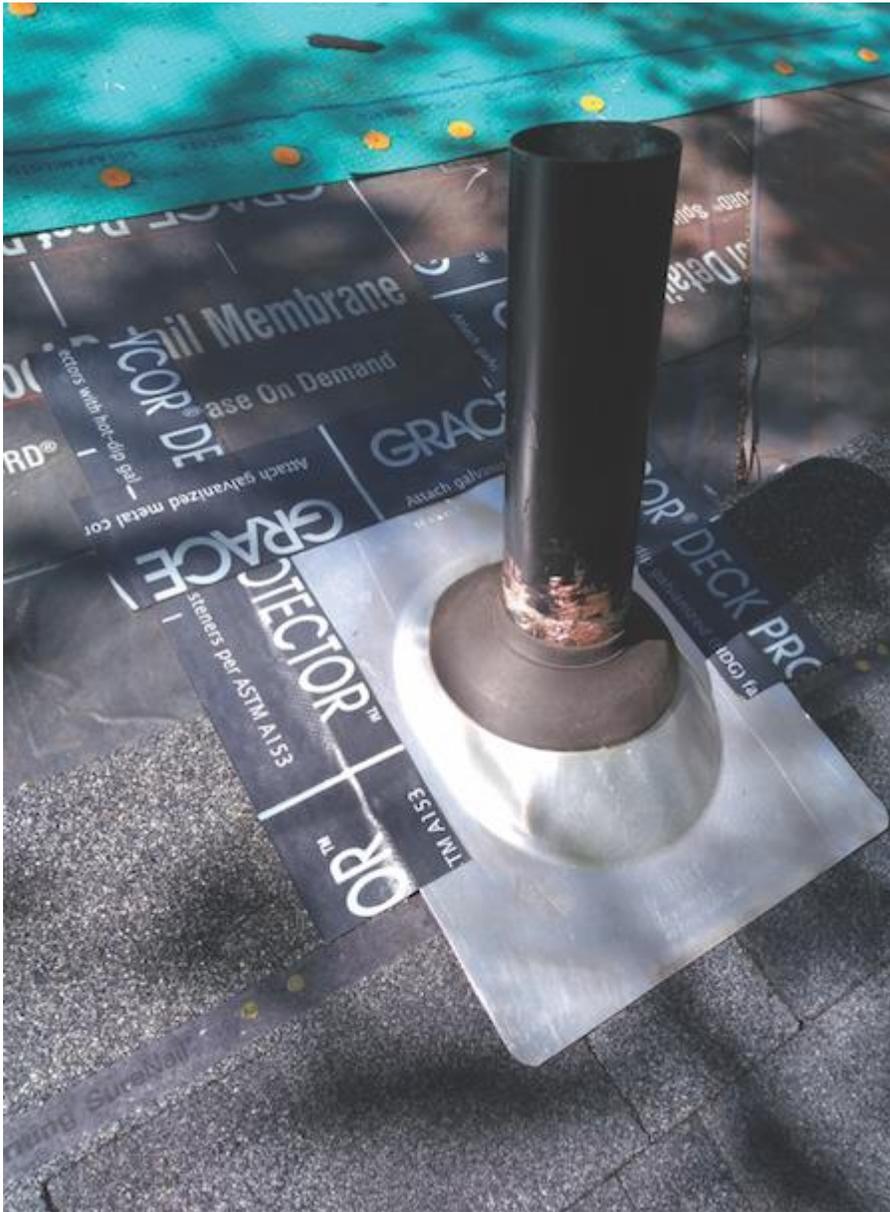
**penetrations.** Plumbing vents are the most common roof penetration, and a surprising number of them are simple "black-jacked." A proper boot (above), installed with a good pell and stick, is the only effective way to seal these penetrations long term.

- **No plumbing-vent boots** had been installed. Instead, these penetrations are often simply "black jacked"—the bases of the vent pipes smeared with asphalt roof cement.
- **No crickets.** Too often, the backs of chimneys are not drainable spaces. They collect leaves and other tree debris that further disrupt drainage, leading to accelerated deterioration of the roofing.
- **Other penetration problems.** All intentional holes in a roof can present problems unless they are meticulously detailed. The best solution is to eliminate them entirely through design. But when they are included, the fact that they are a direct passage into the roof assembly should be cause for utmost care in lapping flashing and cutting roofing accurately to allow water to free drainage around the penetration area.

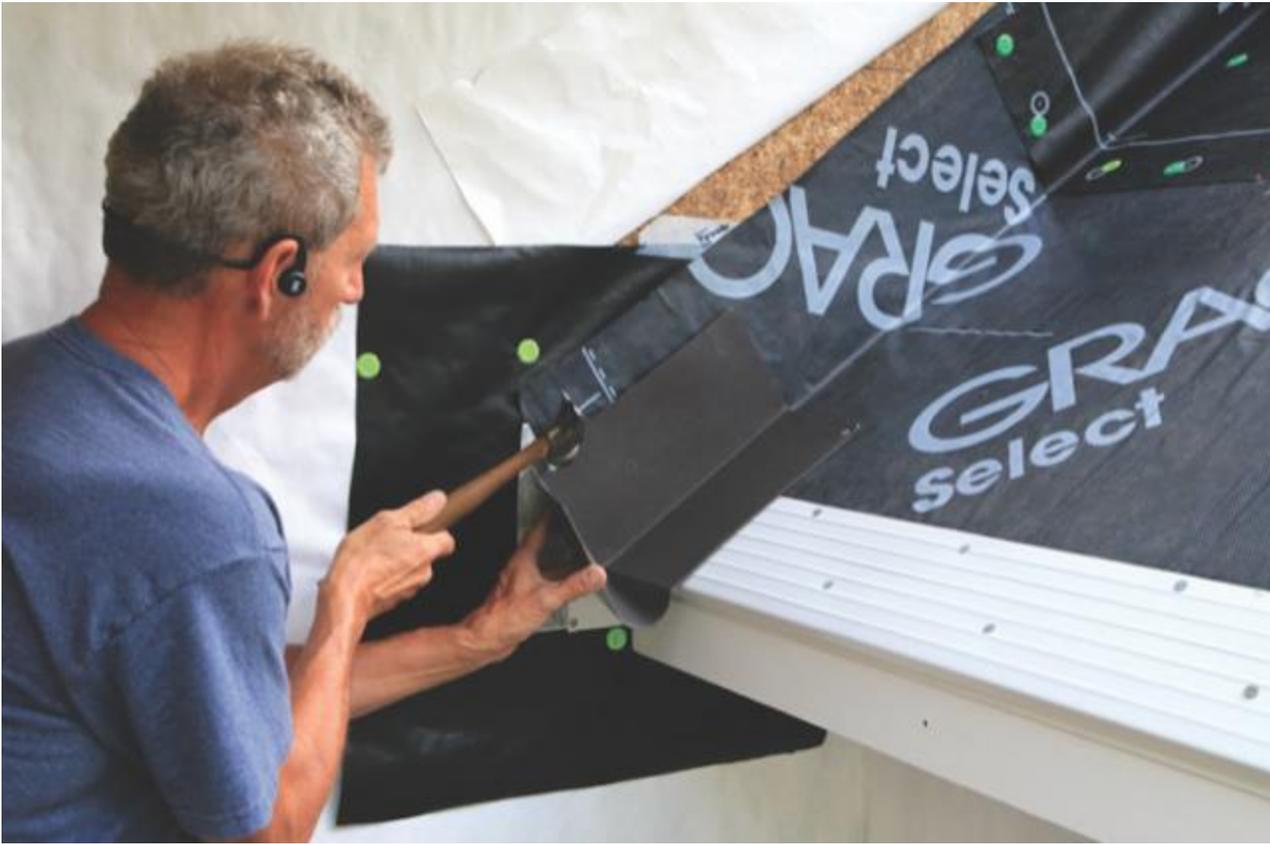
**Guertin Kickouts done right.** Mike Guertin demonstrates how to install a kickout flashing at JLC Live better than anyone in the industry. It's a tough job to do well in a replacement scenario, and there's almost no way you can pull it off without removing some siding.

The model building code has required kickout diverters since 2009. In the [International Residential Code](#), it's worded this way: "A flashing shall be installed to divert the water away from where the eave of a sloped roof intersects a vertical sidewall." Still, they are often avoided in replacement work, as we've discussed in this column before ([July/August 2019](#)), because roofers are often unwilling to open the siding on the wall to interweave the step flashing and kickout with the weather barrier and roofing.

To be effective, a kickout flashing has to be layered with the weather barrier, drip edge, roofing, and siding without creating any reverse laps. Mike's process is super redundant, even including laps with framing and trim, and in any replacement scenarios, his process will have to be adapted. But if the installation doesn't interweave peel-and-stick and the kickout diverter with the weather barrier and drip edge, it's bound to fail. And the only way to succeed with it is by removing siding (and, of course, removing roofing and any existing drip edge or step flashing, but I am assuming here that is a given on any reroof).

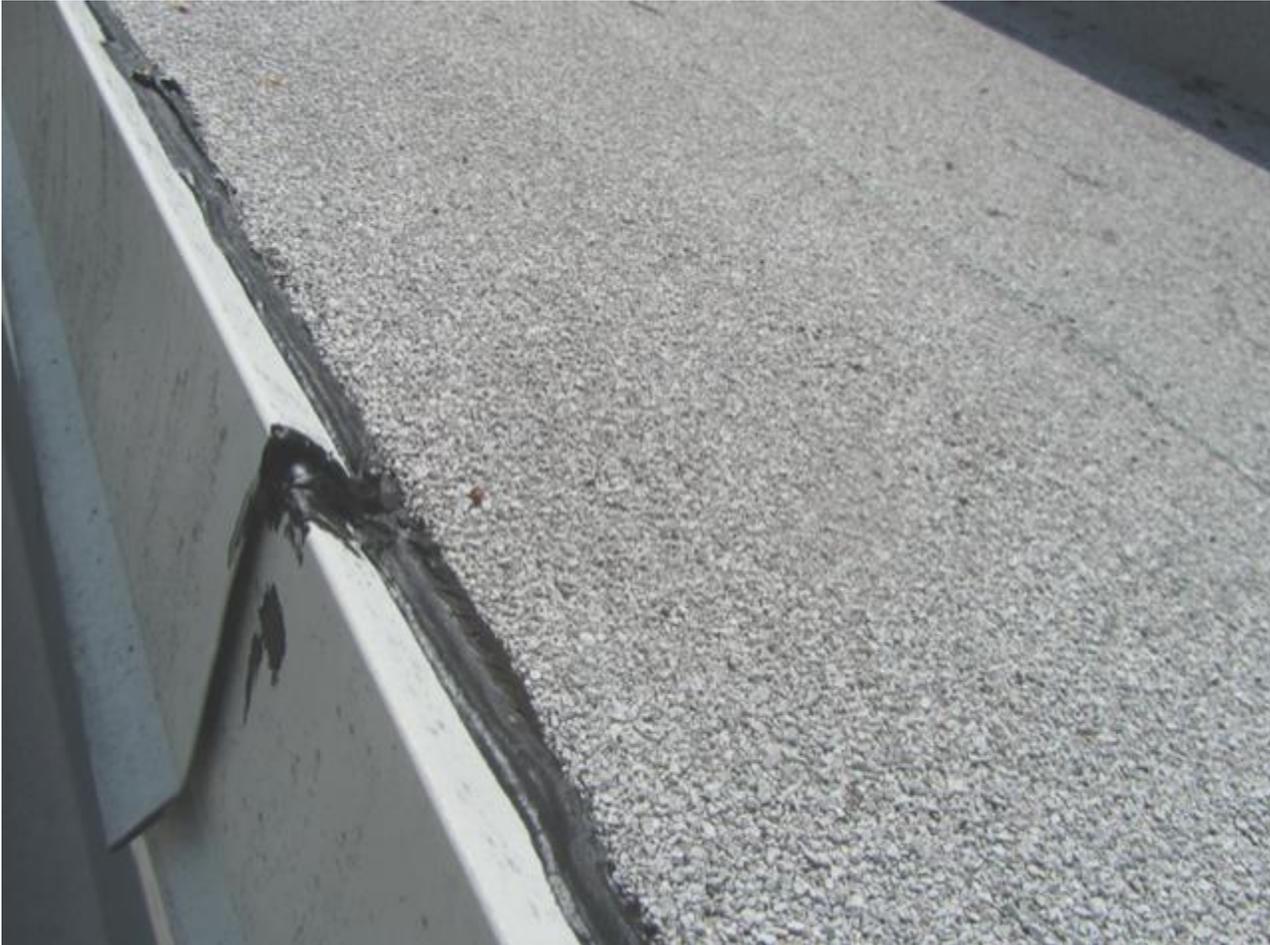
**Horgan/BOWA Critical low-slope details.** Metal edges will move with temperature differences.

Regardless of the roofing membrane, the most common problems with any low-slope roof occur either at perimeter edges or at roof-wall intersections. The main issues Doug Horgan, the head of building science at BOWA, a high-end Washington, D.C.-based remodeling firm, finds often involve metal flashings that leak at joints. Metal changes size significantly over the seasons, which puts a lot of stress on the joints. The best way to keep water out along the roof perimeter is to run flexible roofing materials under the metal and down the vertical surface. The key at walls is to prevent water from getting behind the roofing material. It seems obvious, but often the leaks are through the wall above the roof-wall intersection. But as a replacement roofer, you're stuck managing this water.

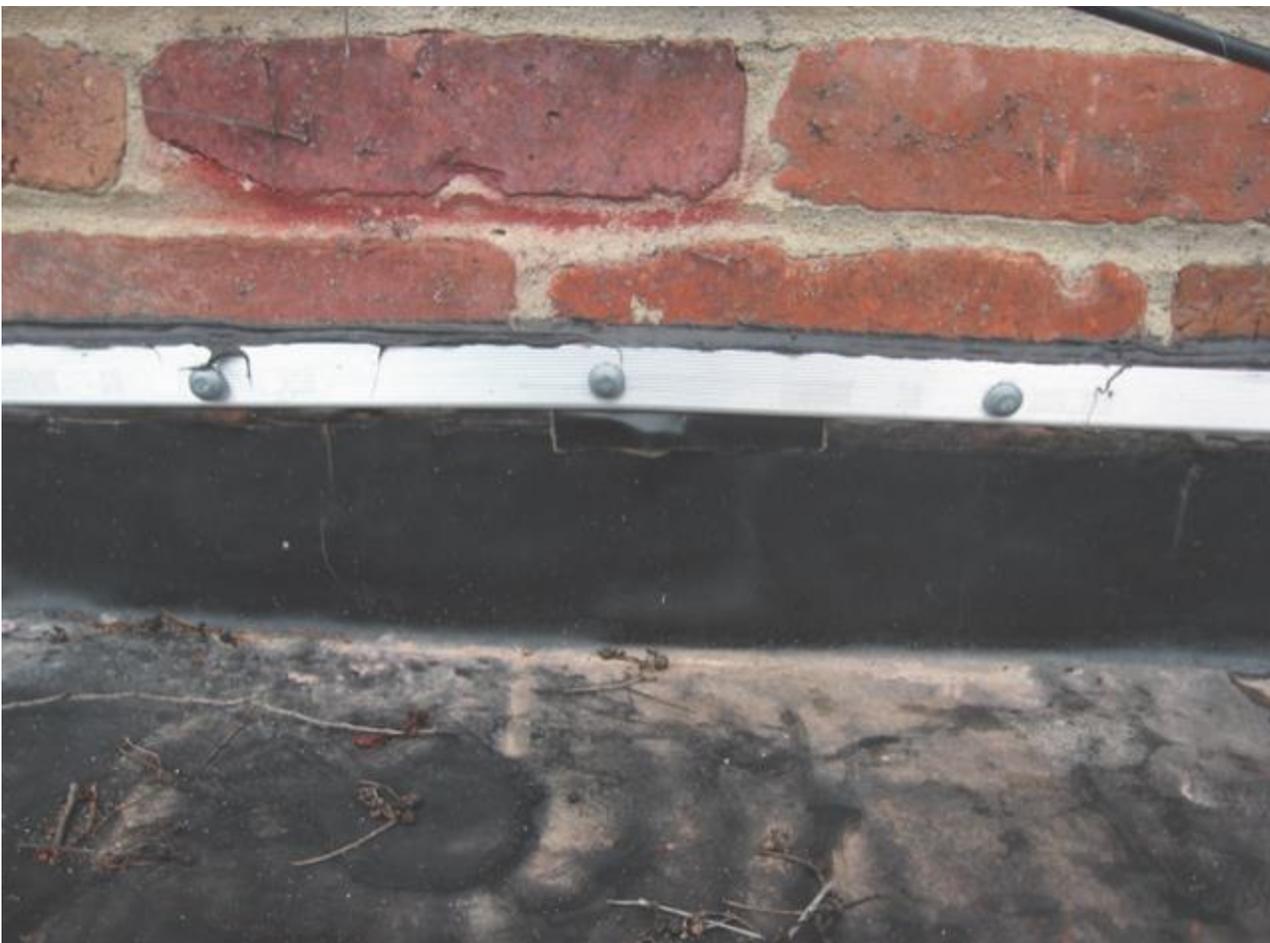
**Horgan/BOWA Critical-low slope details.** At solid masonry walls, a termination bar (which will get lapped by a counterflashing let into the mortar joint) can work, but with brick veneer, only through-flashing will prevent leaks.

With solid masonry walls, it's enough to secure the roofing membrane with a termination bar and counterflash with metal let into a mortar joint above the membrane. This works because solid

masonry will absorb the water and release it (by drying) once the sun comes out. Solid masonry walls are incredibly resilient.

The same is not true for brick-veneer walls. Water regularly is absorbed into the veneer, draining through the air space behind the brick, and can easily leak down past the roof-wall intersection. The only way to adequately manage the water is with a through-wall flashing that collects the water draining through the cavity and directs it out through weep holes. Few replacement roofers are equipped to take on the retrofit of the through-wall flashing. the best you can do is align yourself with a good mason who can take on this work, and direct your client to him or her. What you do not want to do is install a simple let-in flashing, pretending this will work. That flashing will likely fail, leaving you with the liability.
